Charrette  
on  
Design  
Guidelines  
for  
the  
East Plaza

June 29 - 30  
1994

**SURVEY WATER DRAINAGE AND LEAKS  
VOL. II - FEASIBILITY STUDY FOR  
EAST PLAZA MODIFICATIONS**

**HUD BUILDING  
451 7th Street, S.W.  
Washington, DC 20407**

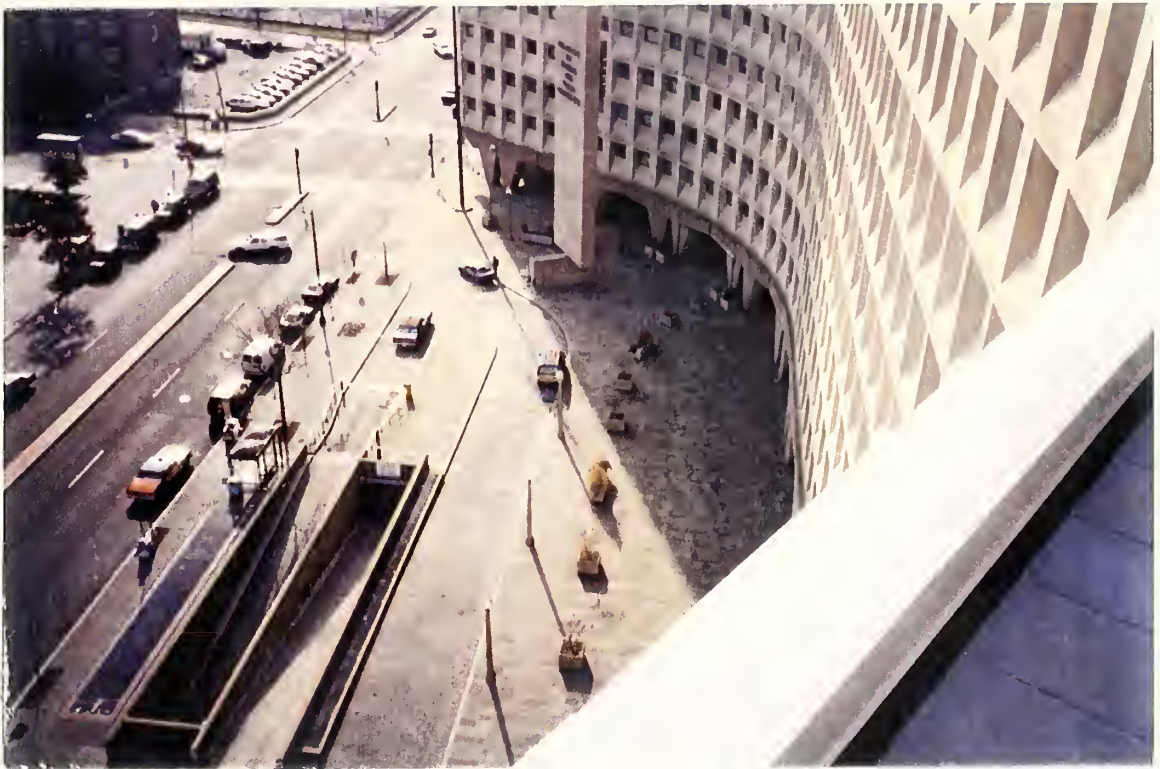
Photograph #1: View of East Plaza looking south from HUD Building roof.

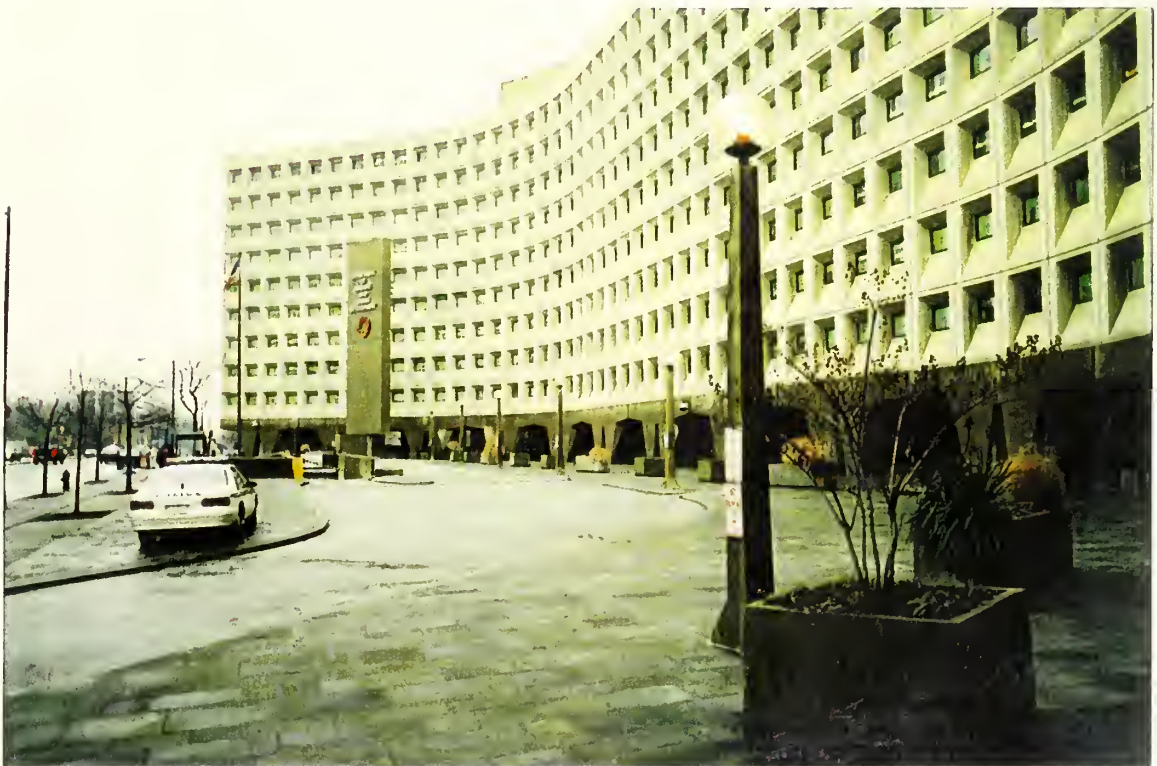
The pole mounted lighting consists of (7) 8 foot concrete poles, each with one 150 watt high pressure sodium lighting fixture of spherical shape (transparent globe) (see Photo #2). The concrete poles are part of the original design but the fixtures on top of them have been changed. These lighting fixtures are served from (H.I.D.) panel "RP1FA" (225A - 3 phase - 4 wire - 120/208V) located in the southeast electrical closet on Ground floor and from panel "RP1HA" (225A - 3 phase- 4 wire - 120/208V) located in the northeast electrical closet on the Ground floor.

Photograph #2: View of East Plaza looking south.

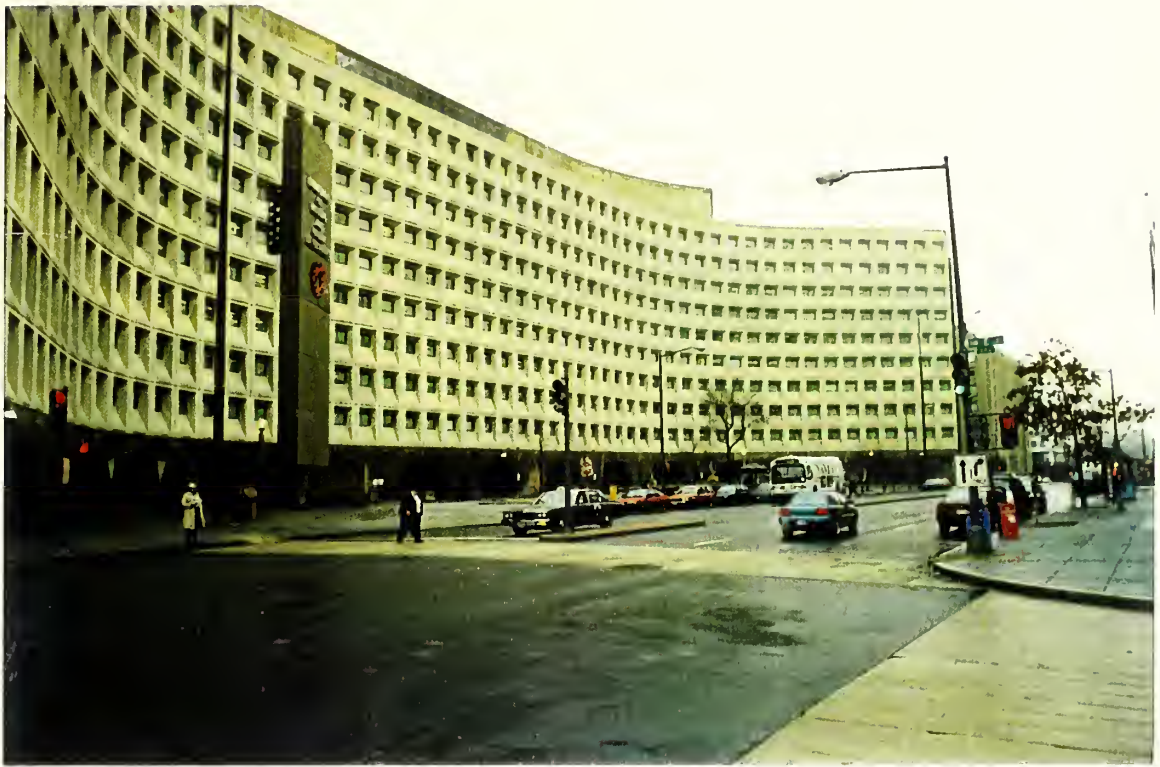
Photograph #3: View of East Plaza looking north from across Seventh Street

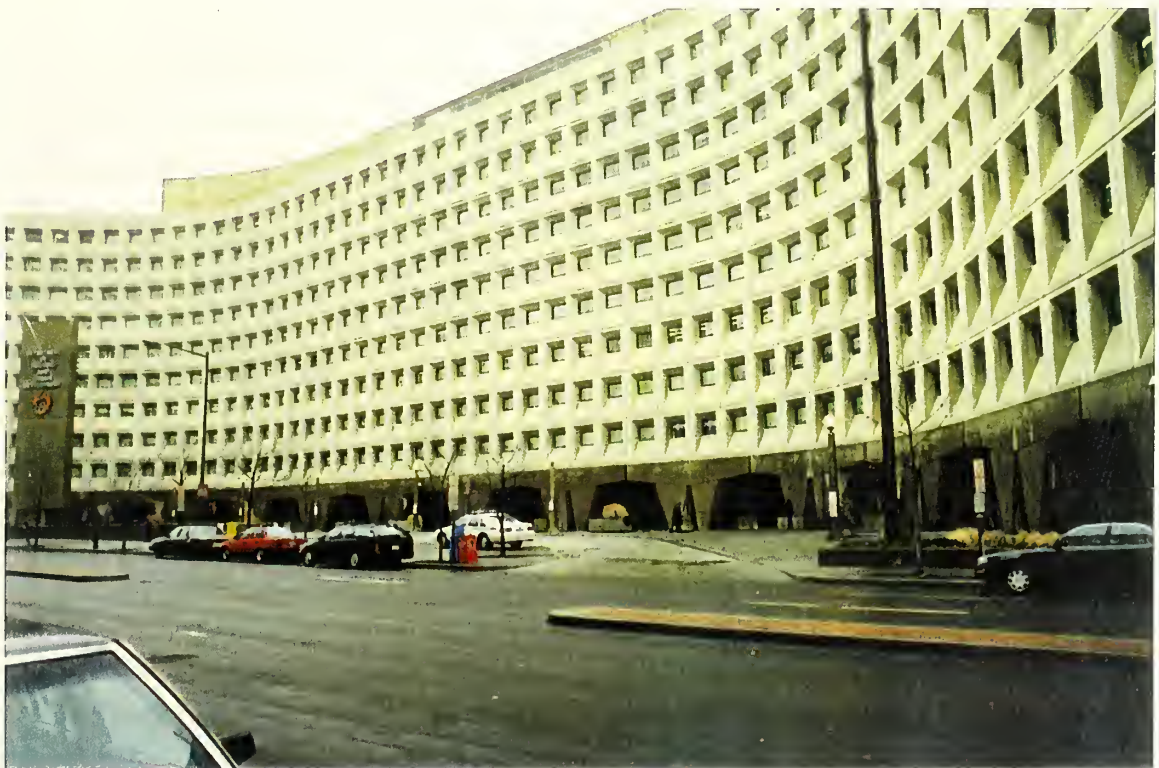
Photograph #4: View of East Plaza looking south from across Seventh Street

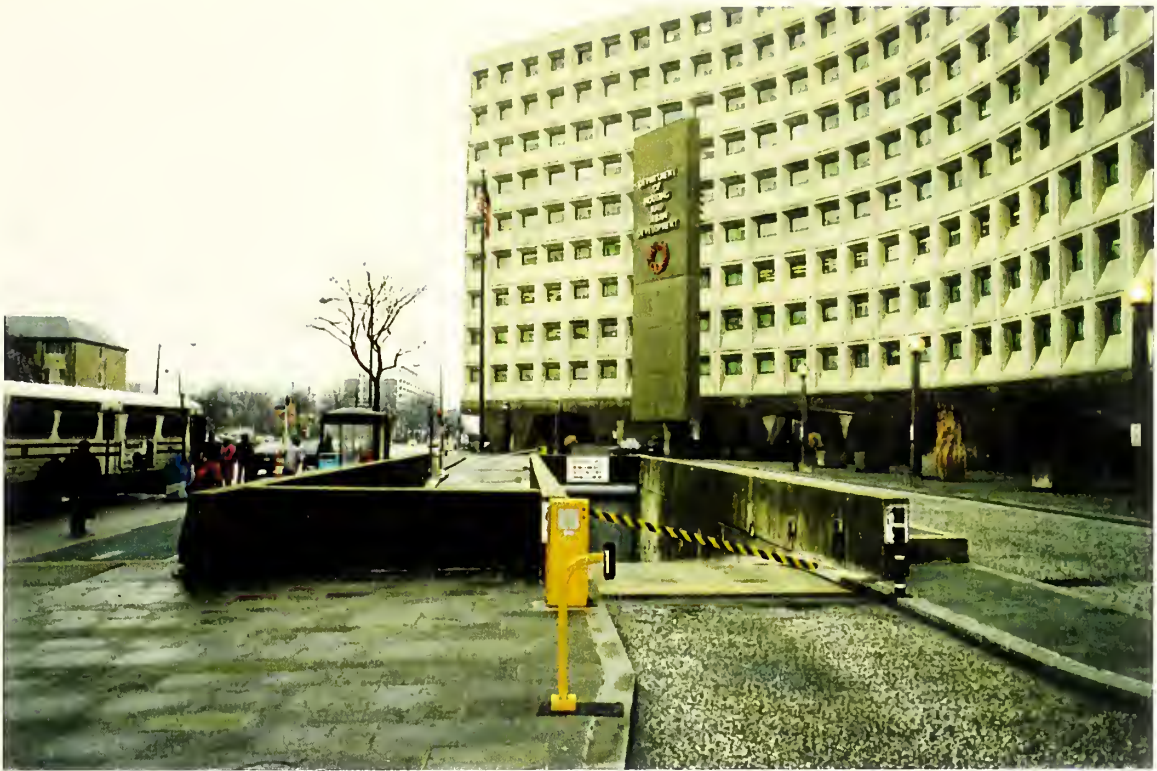
Photograph #5: View of garage entry ramp in East Plaza.

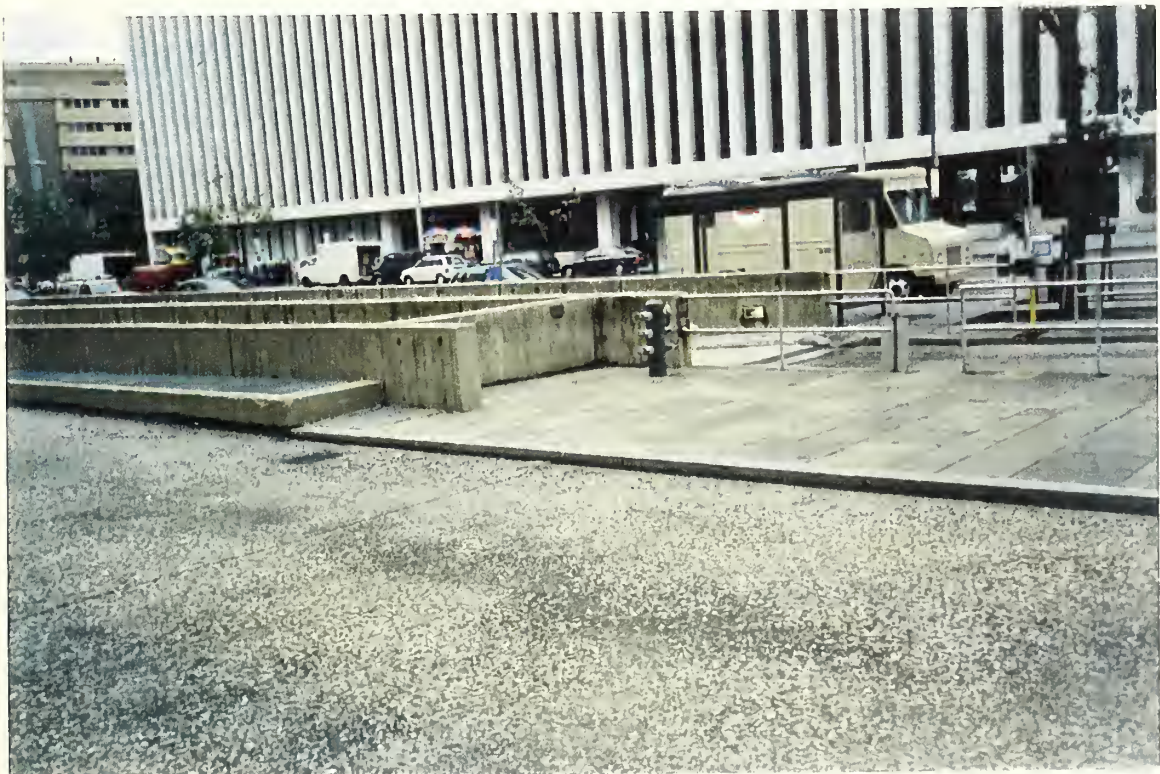
Photograph #6: View of top of garage exit ramp in East Plaza

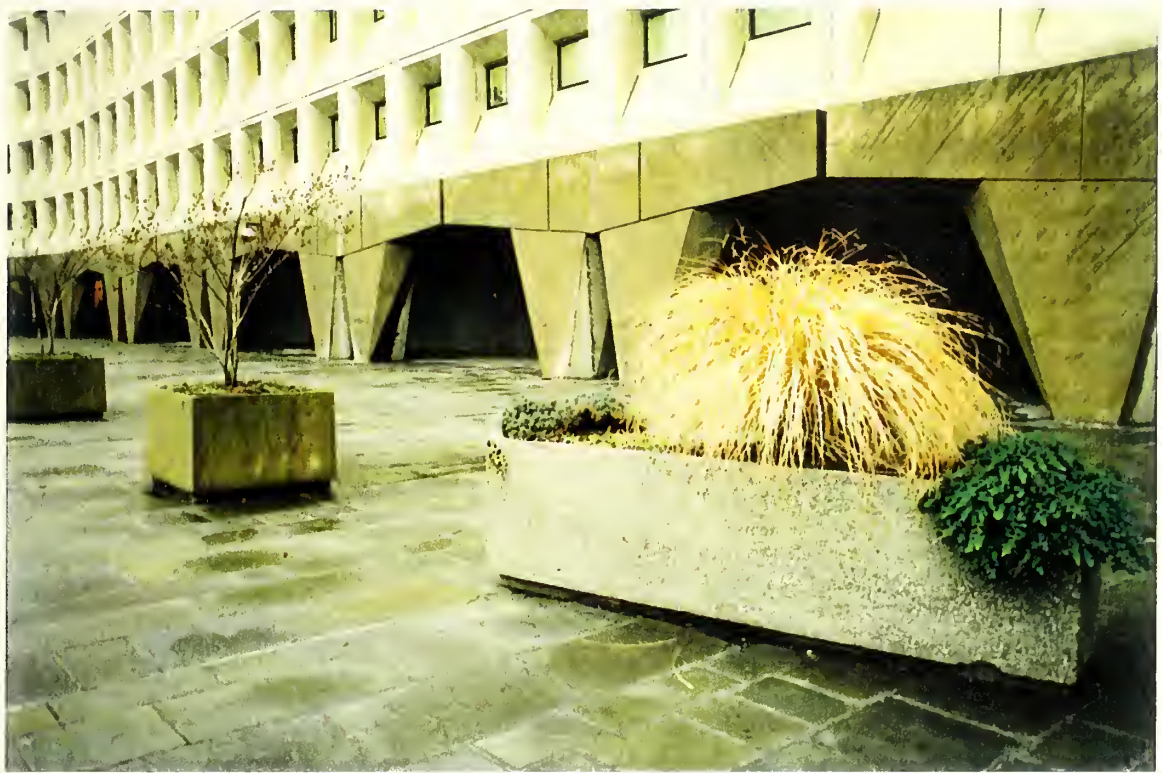
Photograph #7: Planters on East Plaza.

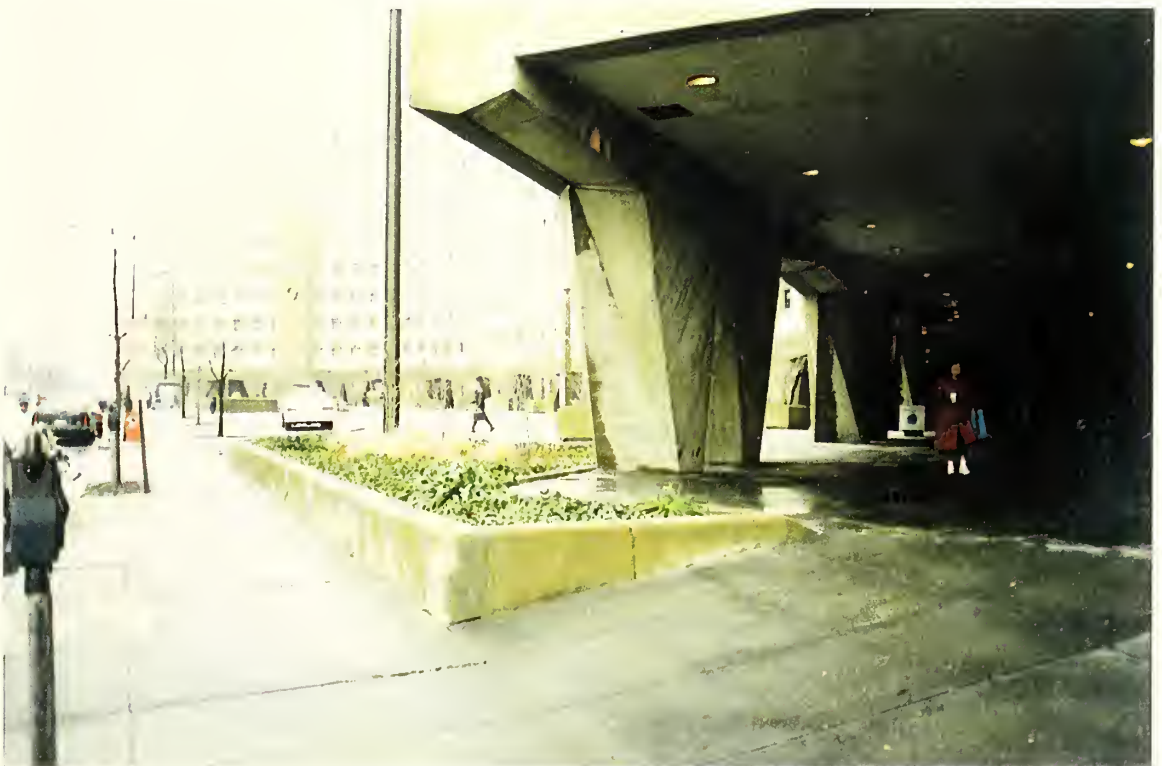
Photograph #8: Planter and flagpole at north end of East Plaza

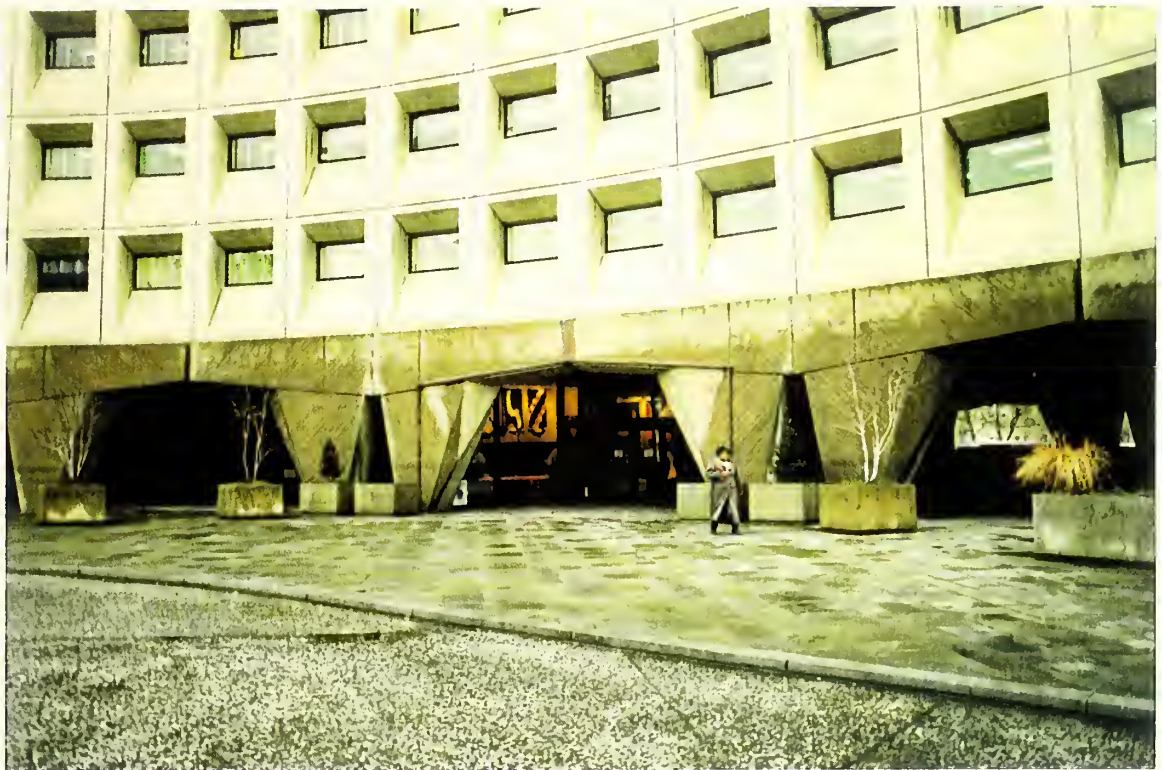
Photograph #9: View of HUD Building entry at south end of East Plaza

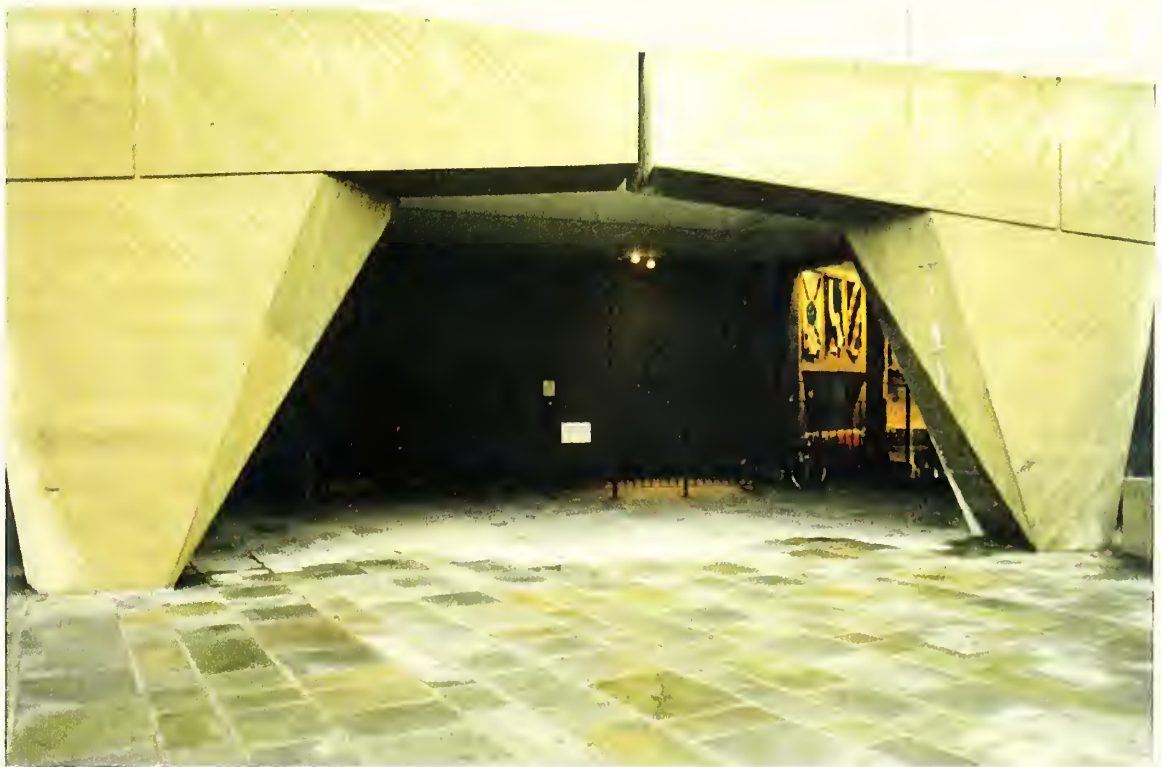
Photograph #10: Bicycle parking enclosure next to the HUD building entry at the north end of the East Plaza

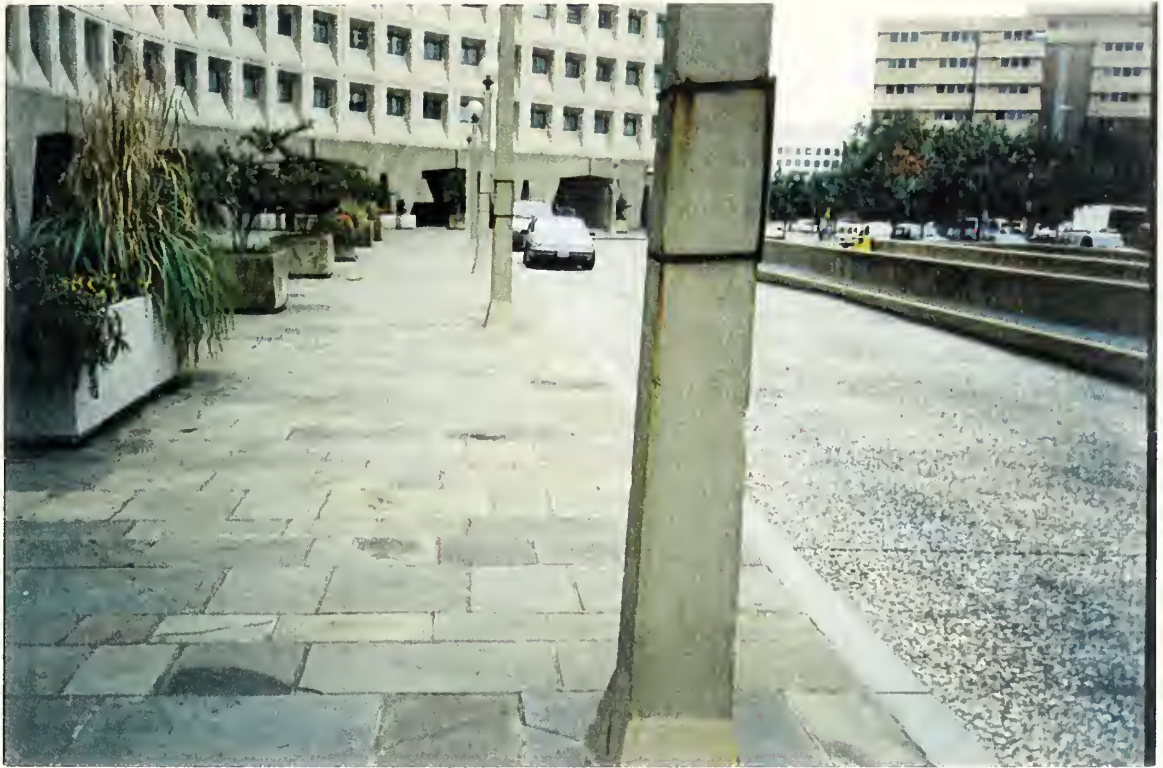
Parking restriction signage for the driveway on the plaza is comprised of small white and red metal signs attached to the concrete lighting standards with rusting metal straps.

The existing pylon sign is an important original design feature of the plaza and provides easily visible identification of the building. The small blue signs north and south of the plaza, while not particularly consistent with the building design, do conform with the standard signage used for other government buildings in the neighborhood, and so help provide continuity. The metal traffic control signs are not consistent with other materials and design in the plaza. Their rusting metal straps are staining the concrete lighting standards.

Photograph #11: Concrete lighting standard with rust stains from sign mounting.

The concrete pylon sign must be retained. The blue metal signs can remain, and are not directly affecting the appearance of the East Plaza. The metal parking restriction signs should be removed from the lighting standards. They should be replaced with signage more compatible with the plaza design mounted in a way that doesn't damage original plaza features.

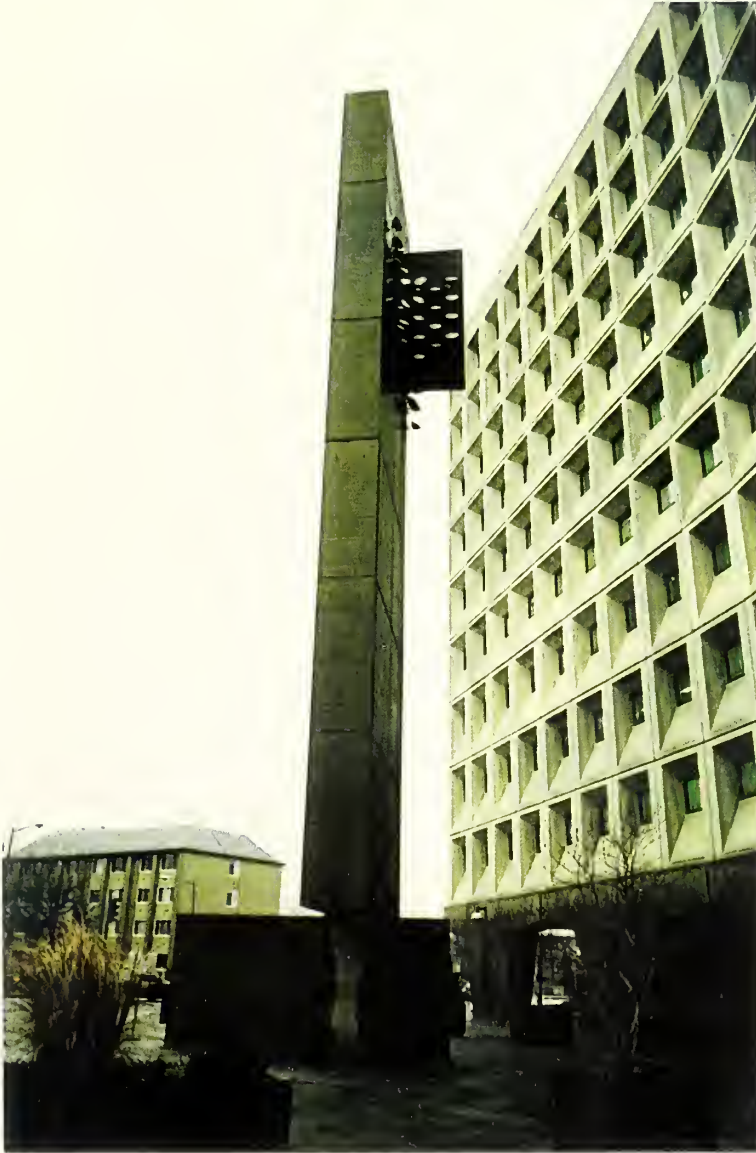
Photograph #12: Lighting mounted behind concrete pylon sign.

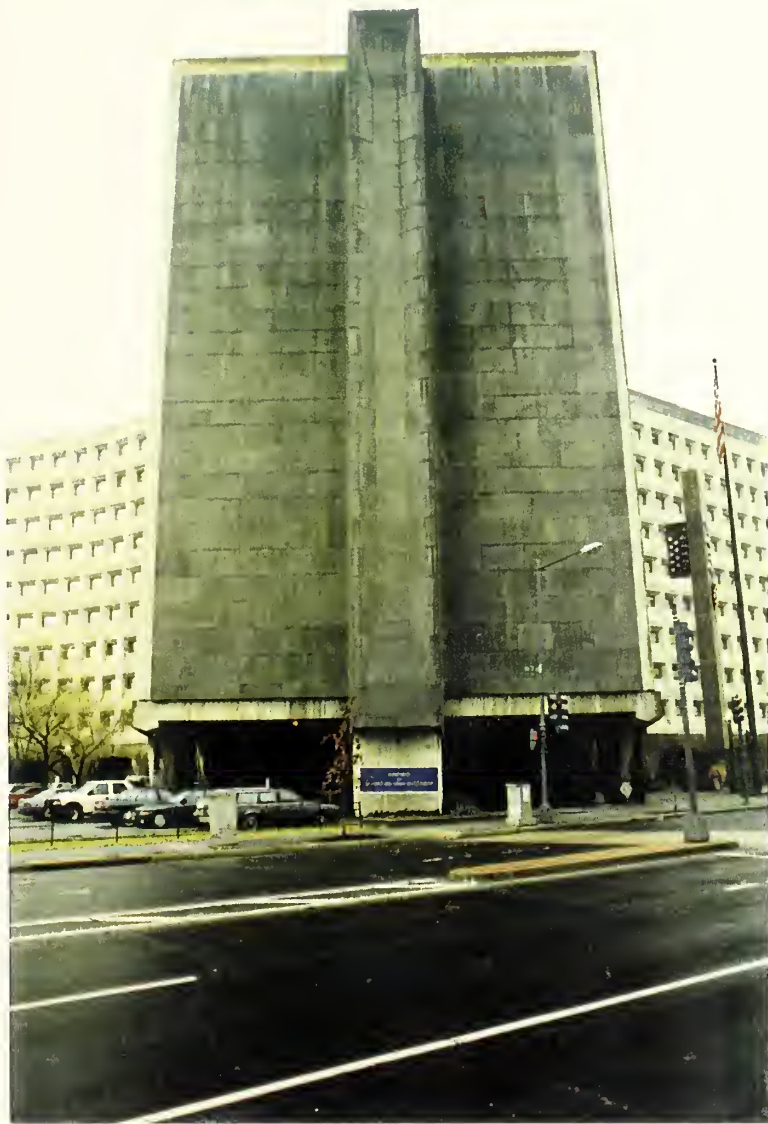
Photograph #13: Southeast end wall of HUD Building.
